TEST REPORT

Reference No. : WTF17F0786002C

Sample Name : Teapot and cup set

Model No. : MO7343

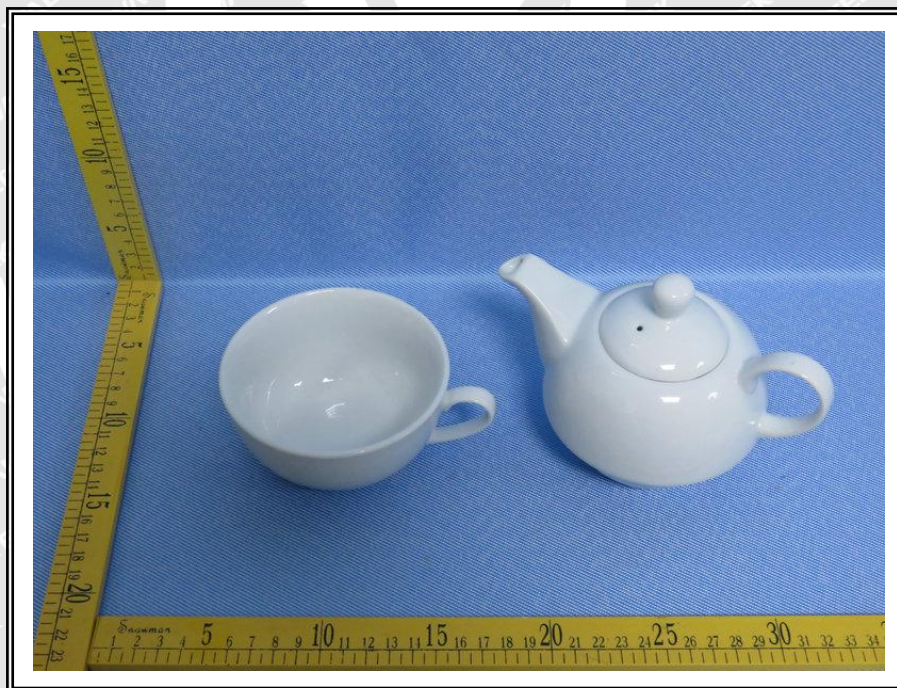
Sample Photo:

- No.1: White ceramic lid (Ceramic)
- No.2: White ceramic teapot (Ceramic)
- No.3: White ceramic cup (Ceramic)

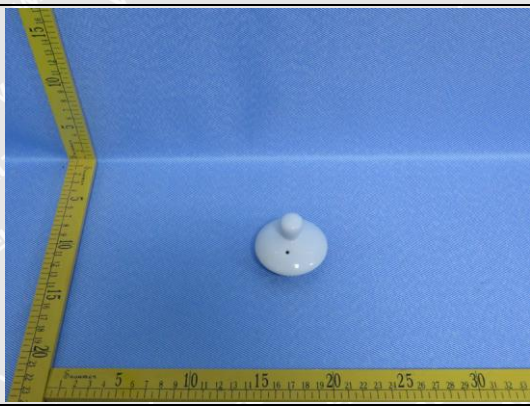
No.	Photo of testing part	Parts Description	Client Claimed Material
1

White ceramic	Ceramic
2

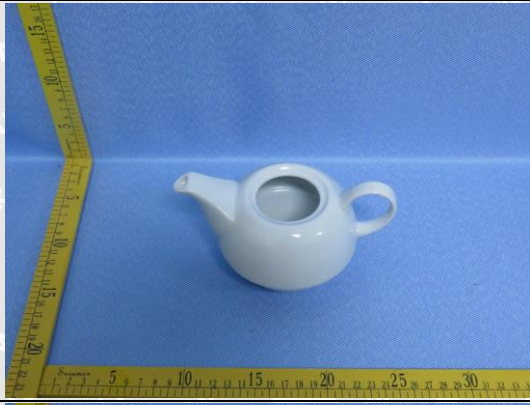
White ceramic	Ceramic
3

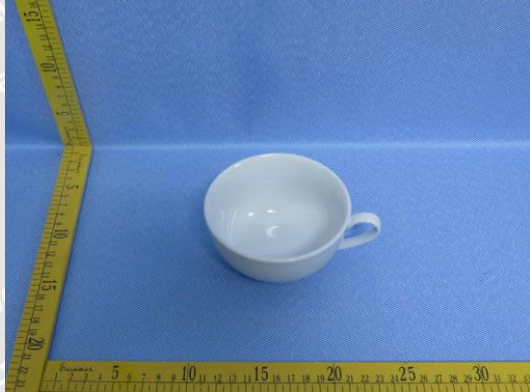
White ceramic	Ceramic
