YAI				
TEST REPORT				
Test Report #	18A-003634-1	Date of Report Issue:	September 4, 2018	
Date of Sample Received:	August 31, 2018	Pages:	Page 1 of 6	
CLIENT INFORMATION:			in the second	
Company:	Mid Ocean Brands B.V.			
Address:	7/F,Kings Tower,111 King Wan,Kowloon,Hongkong			
SAMPLE INFORMATION:			นึงสีสนับสีมากับก็เป็นในการการการการการการการการการการการการการก	
Product Name:	Tailors measuring tape			
Model/style No.:	M08219			
Main Material:	-			
Buyer:	Mid Ocean Brands B.V.			
Supplier:	100396			
Country of Distribution:	EU			
Testing Period:	08/31/2018-09/04/2018

TEST RESULTS SUMMARY:

CONCLUSION	TEST(S) CONDUCTED
PASS	Regulation (EC) No. 1907/2006 REACH Annex XVII, Item 63 Lead in Substrate
	Materials
PASS	Regulation (EC) No. 1907/2006 REACH Annex XVII, Item 23 Cadmium in Substrate
	Materials

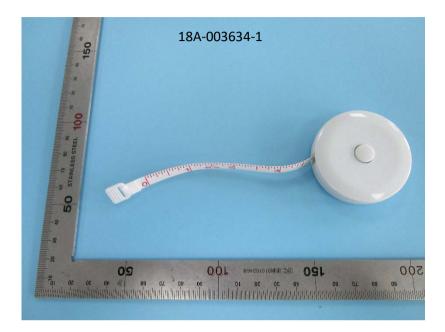
SAMPLEPHOTO:

Specimen No.	Specimen Description	Location
1	White plastic	Handle
2	White plastic	Button
3	White plastic	Shell
4	Red coated white soft plastic	Таре
