# TEST REPORT

**Reference No.** ..... : WTF18F05112542C

**Sample Name** ..... : Double wall vacuum bottle

**Model No.** ..... : MO9431

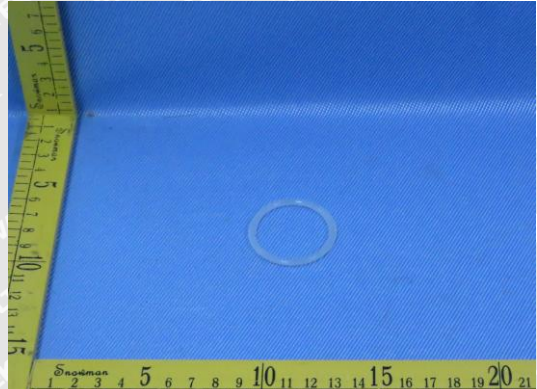
No.	Photo of testing part	Parts Description	Client Claimed Material
1

Translucent silicone rubber	Silicone rubber

Food Simulant	Test Condition	Result (mg/kg)	MDL(mg/kg)	Limit (mg/kg)
		No.1		
3% Acetic Acid	70°C for 6 hours	ND	20	60
50% Ethanol	70°C for 6 hours	ND	20	60
